**AK360**  
PRESERVATION BOARD  
SUBMISSION

**ALBRIGHT-KNOX ART GALLERY**  
**PROPOSED ROOFING AND MASONRY REPAIRS**  
**TO 1905 & 1962 BUILDINGS**  
**BPB SUBMISSION**

April 9, 2019

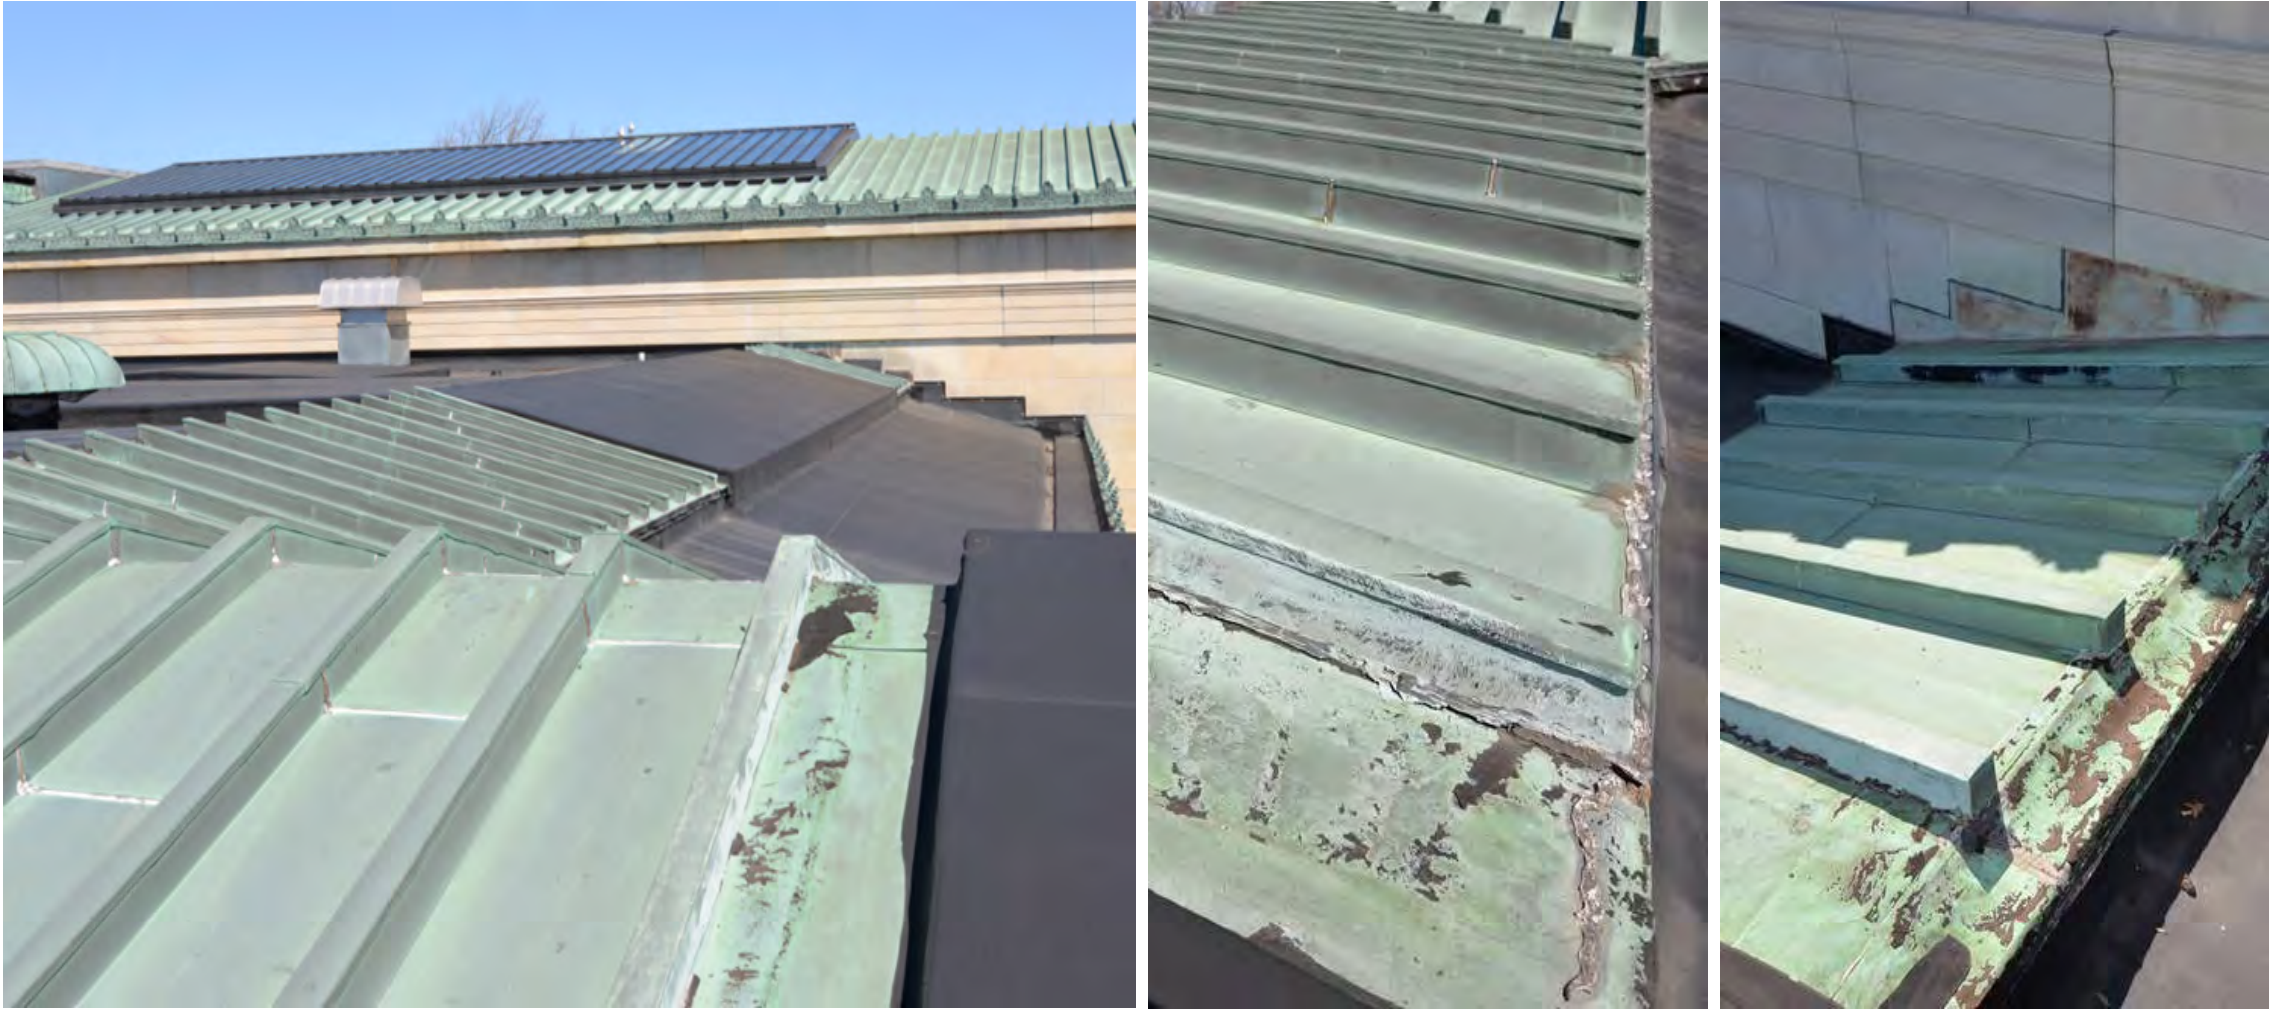
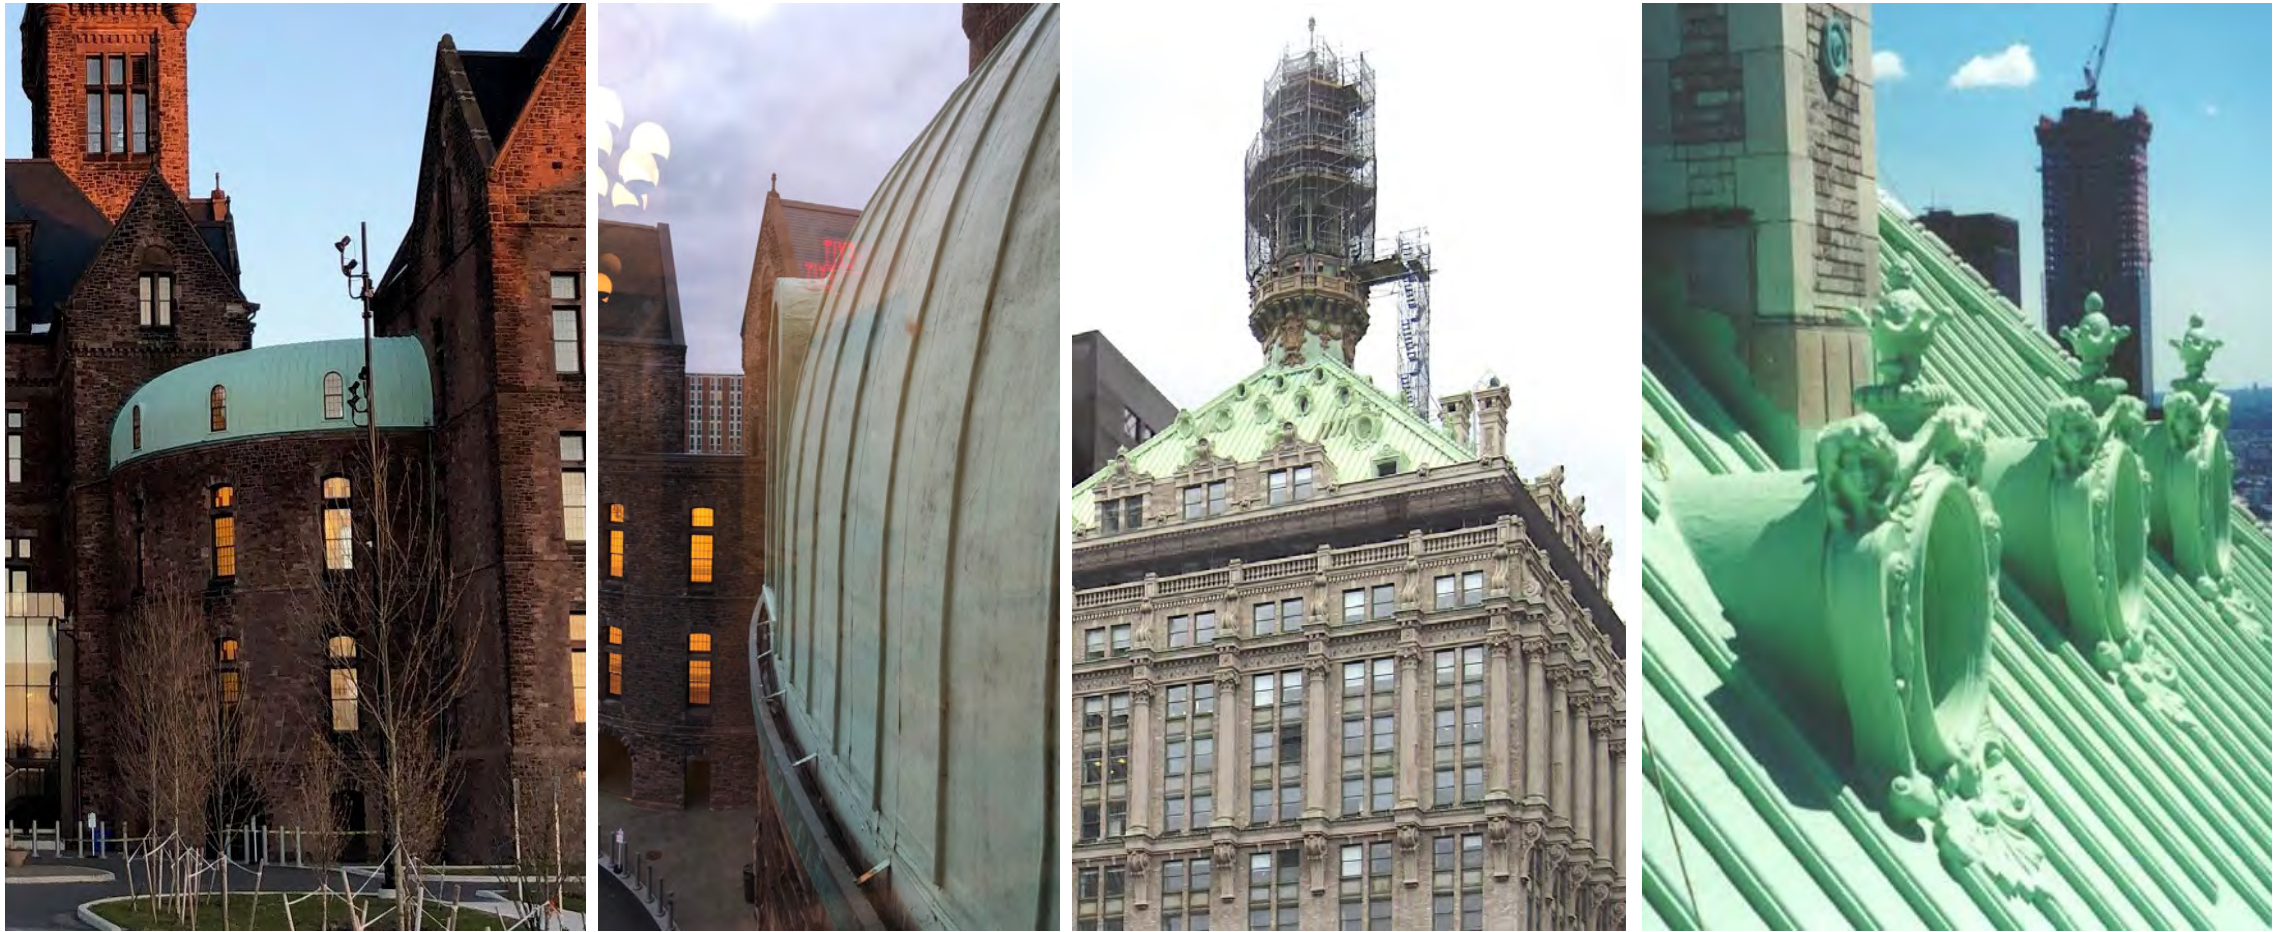
Batten-seam sheet metal roof

**Existing Condition:** Photos showing deteriorated sheet metal roofing with open joints/ seams and signs of previous repair programs. The sheet metal roof was recently found to be the origin of leak that damaged a painting in the gallery. Sheet metal roof is 114 years old and as such past its expected service life.

**Proposed Scope:** Retain the existing sheet metal roof. Overcoat with liquid-applied reinforced membrane in color to match existing copper patina; overcoat is recommended to retain the historic batten-seam aesthetic while extending the life of the deteriorated fabric. This has been performed successfully at other Landmarked buildings, examples show HR Richardson Complex in Buffalo (photos left) and the Helmsley Building in NYC (photos right).

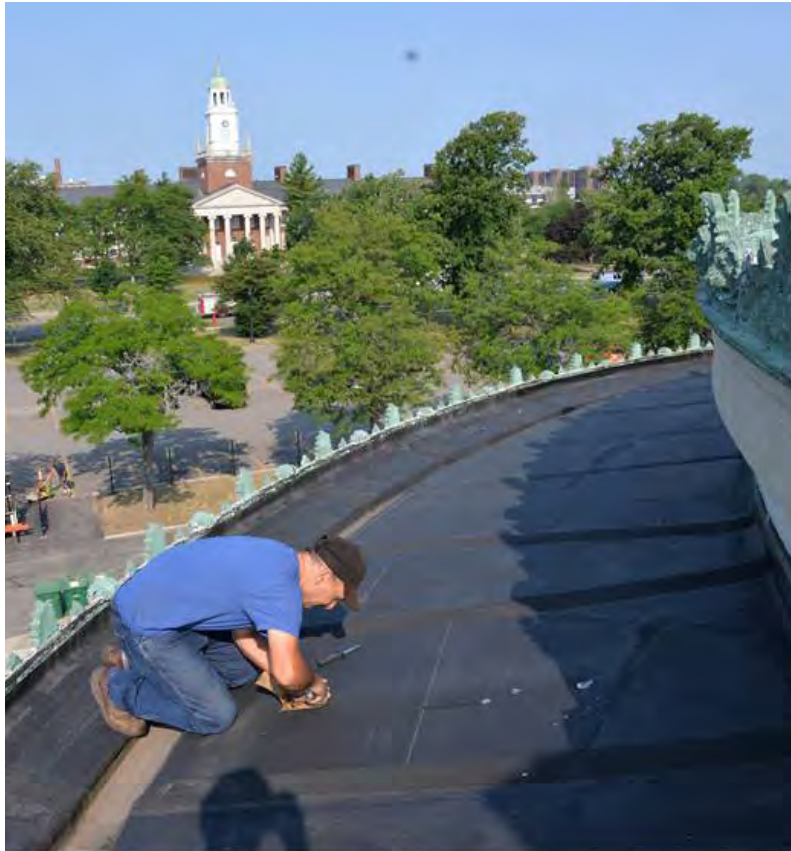
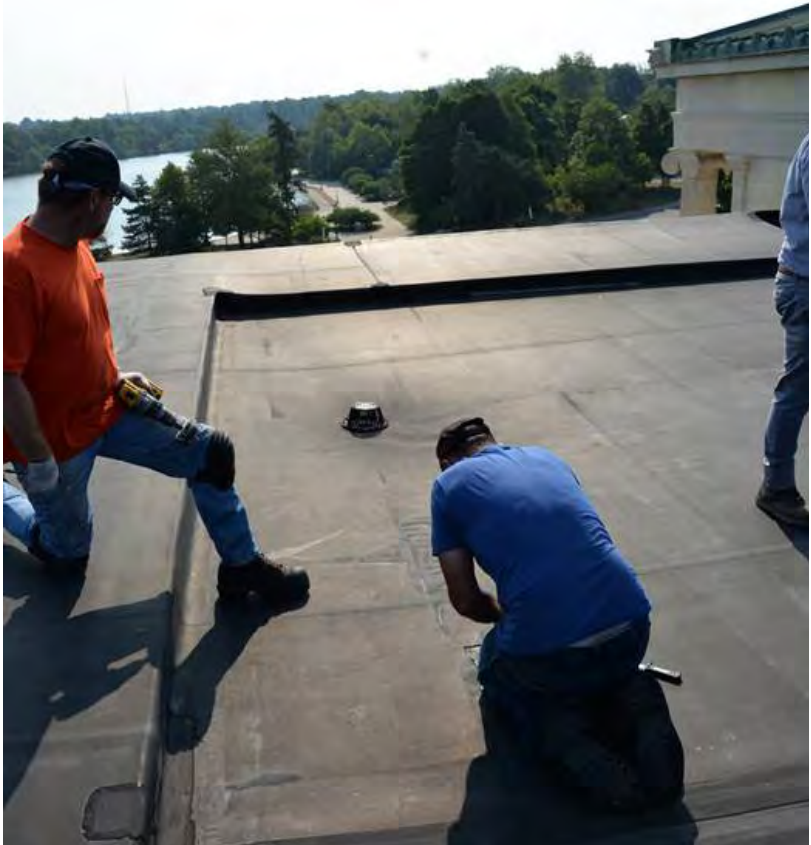
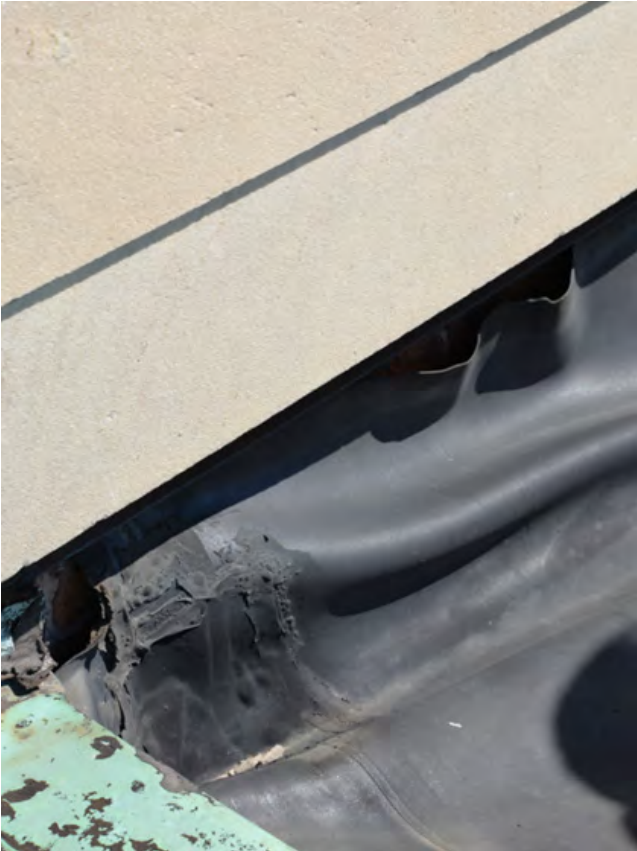
EPDM Roofing

**Existing Condition:** EPDM membrane which was installed in the 1990’s is past its expected service life with leaks and failures occurring regularly. The membrane is no longer under warranty and the Museum would like to replace the roof membrane to obtain a long term warranty.

**Proposed Scope:** Remove and replace existing EPDM rubber membrane roofing with a liquid-applied reinforced roof membrane and SBS base layer that is more appropriate for a building that houses priceless works of art. Color of the membrane to match the patina of the original copper roof at visible areas, which the EPDM roofing replaced. Photo on left shows existing roof patchwork of historic copper and EPDM roofing while photo on right shows photo-montage of proposed design intent, which recalls the original appearance of the roof.

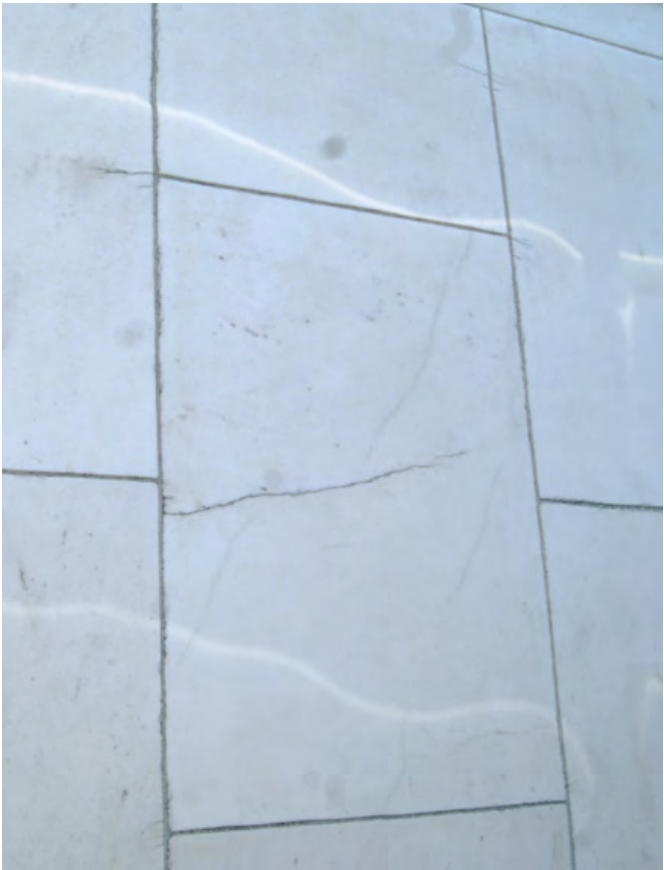
Crack in marble.
